CLARK RANGER FORKLIFT (CRF)

SUBJECT: Final Report - Clark Ranger Forklift (CRF)

FINAL REPORT

ACTIV Project No. ACL-29/68I

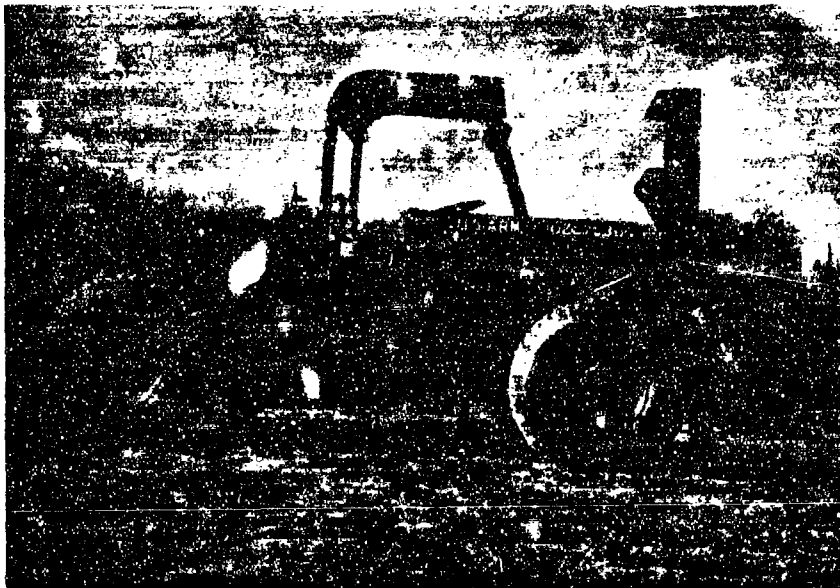
FIGURE 1. Clark Ranger Forklift

The CRF is a gasoline engine driven, 4000-pound capacity forklift truck. It is articulated, has high flotation pneumatic tires and can be used in either two- or four-wheeled drive. It is 198 inches long, 72 inches wide, 102 inches high, and weighs 9,345 pounds empty. Its outside turning radius is 164 inches; its inside turning radius is 52 inches. The ground clearance is twelve inches. It has four forward and four reverse gears; its top speed loaded is 22 mph. The forks are adjustable by hand to a maximum spread of 60 inches. It has a tow pintle on the rear with a 5676-pound draw bar pull capability. The CRF is powered by a six cylinder, L-head, aircooled Continental engine. The lift is hydraulically operated. The hydraulic system is powered by a gear-driven vane-type pump. The system is protected by a built-in pressure relief valve. The forklift is capable of operating on unprepared surfaces, sand, mud, and inclines. It is classified as a semi-rough terrain forklift. (See figure 1.)

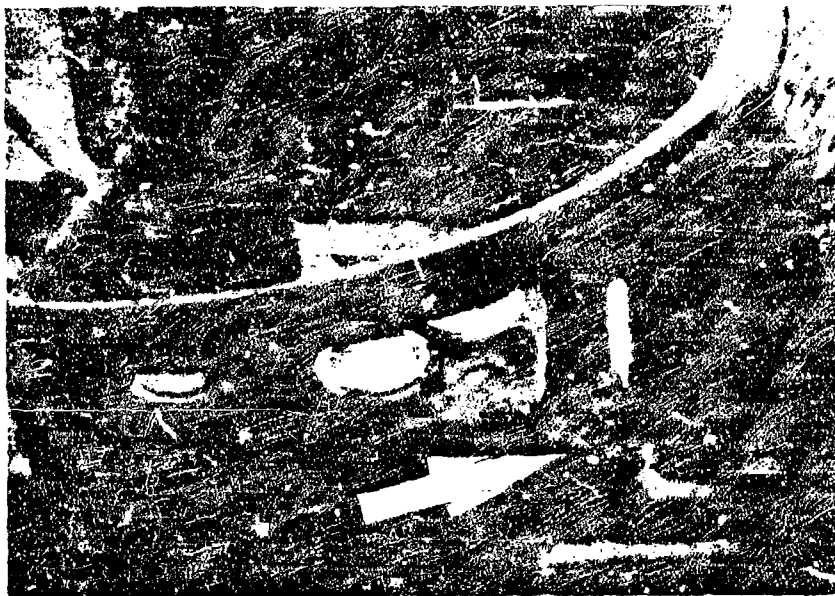
FIGURE 7. Ignition switch location.

d. Several units commented on the location of the ignition switch and the fact that no "off" or "on" position was visible (see figure 7). Consequently, the switch was often left on inadvertently, causing the battery to discharge.

(2) Several recommendations were received that a 24-volt electrical system be installed and that a standard size battery be used. Recommendations were received to replace the starter, generator, and voltage regulator with models designed for hot, humid climates. It was recommended that the ignition switch be relocated to a position where it can be easily seen and that the "off" and "on" positions be clearly marked. A small red warning light should be added to remind the operator to turn the switch off.

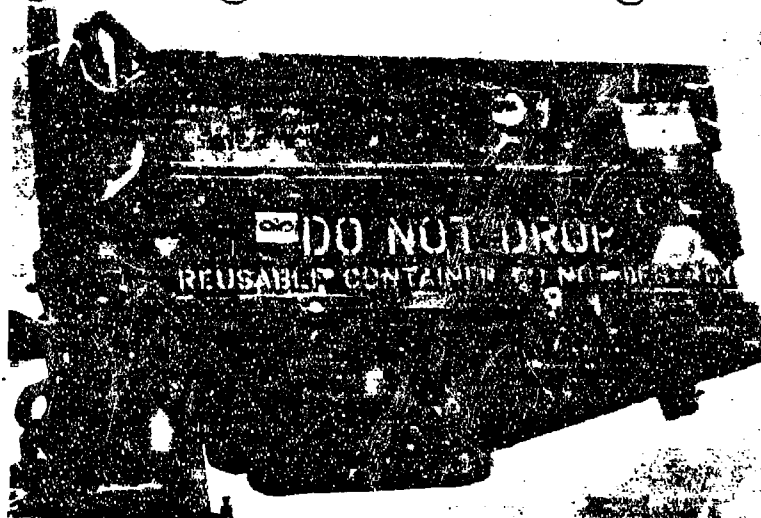
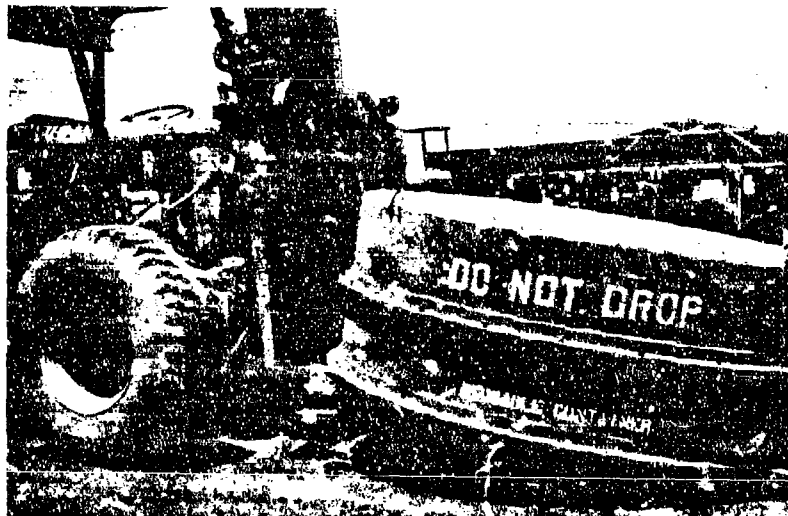
APPENDIX 2 TO ANNEX A

In several instances, the short forks were cited as a limiting factor in handling some loads. Large containers such as a CH-47 transmission, although liftable, balanced so precariously as to be unsafe to haul (see appendix 2). Further, pallet loads could not be removed from stake and platform trucks if they were loaded in the center of the truck. The percentage of operations limited by the length of the forks was relatively small, constituting less than five percent of the workload. However, a 24-inch extension would further increase the forklift's utility.

Above and below are examples of cargo which cannot be carried over bumpy ground because the forks are too short to reach well beyond the center of gravity.

(1) Several operators and commanders recommended that a simple modification be made to lock the forks in place. The lock should be easy to engage and disengage.

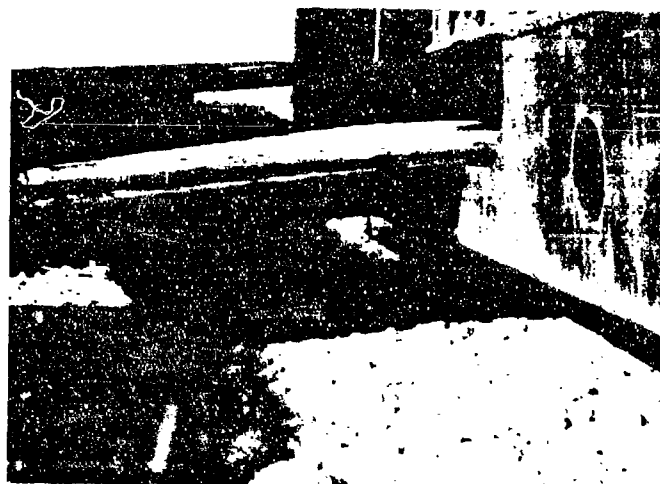
APPENDIX 3 TO ANNEX A

Even though the fork could be forced into the lower side of the load and that side raised and blocked, the CRF was generally unsuited for picking up loads in rough terrain.

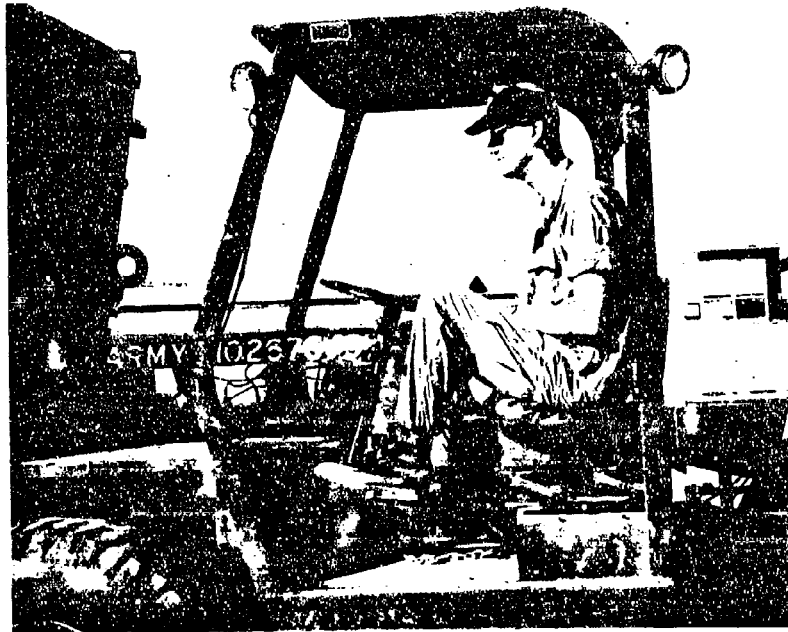
APPENDIX 1 TO ANNEX B

The positioning of the brake and clutch pedals and the large amount of travel required by their design make them awkward and tiring to use. As can be seen in the photograph, the knees can be parted to keep them from getting stuck under the wheel. However, to preclude the possibility of getting the knees stuck under the wheels during a critical operation, it is desirable that this situation be alleviated.

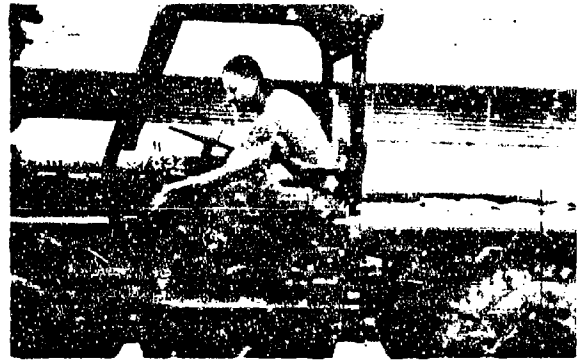
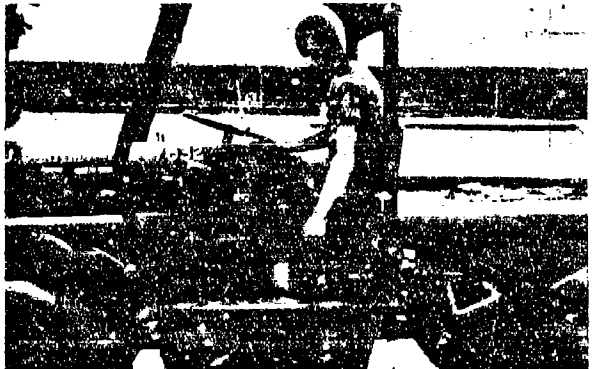
APPENDIX 2 TO ANNEX B

Three separate motions are required to engage the parking brake because of the awkward position and the portion of its travel arc where the resistance is greatest. It would be more practical to locate it below the seat as indicated in the lower right picture.

(3) Relocation of the hand brake to a position just below the operator's seat on the left side was recommended.
